POTOMAC RIVER BASIN

Name Of Dam: NEWMAN LAKE DAM  
Location: HARRISONBURG, VIRGINIA  
Inventory Number: VA. NO. 66001

# PHASE I INSPECTION REPORT NATIONAL DAM SAFETY PROGRAM

SCHNABEL ENGINEERING ASSOCIATES, P.C./  
J. K. TIMMONS AND ASSOCIATES, INC.

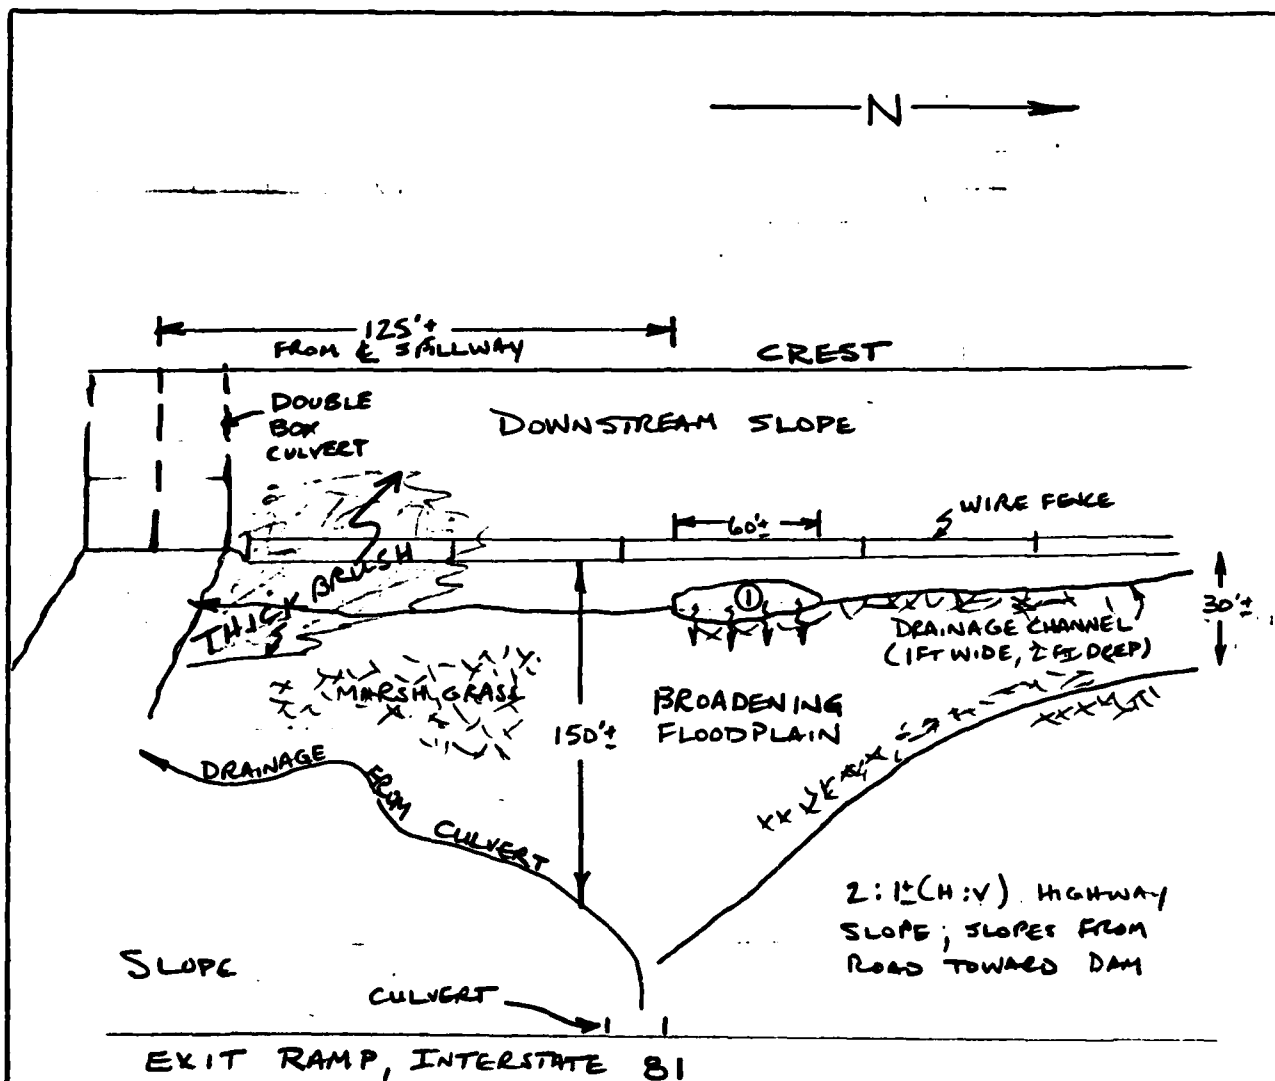
SHEET NO. 1 OF 2  
 JOB NO. V80106

Seepage was observed in an area approximately 60 ft long and 20 ft wide along the toe of the downstream slope at a point roughly 125 ft left of the spillway centerline. Although no flow or turbidity was observed, the area did include iron staining. Much of the area below the downstream slope was water saturated as a result of previous rainfall. Only those areas exhibiting iron staining were identified as seepage. It is likely that the wet marshy area near the box culvert is also the result of seepage through the dam. A field sketch is provided as Sheet 1 of Appendix III.

6.2.2 Subdrains and Seepage: There is no known drainage system and apparently no foundation drain outlets. Seepage observed during this inspection (See Sheet 1, Appendix III) is believed in the same general location as the seepage investigated by SCS personnel in late 1968 or 1969. The report developed in conjunction with this earlier inspection is included as Appendix IV. It was concluded in the SCS report that this seepage did cause "some instability of the dam which could result in failure of the structure." It was proposed that either an upstream cutoff or a downstream drainage system be constructed to help alleviate the seepage problem. Neither James Madison University or the local SCS office have any information verifying whether any of the recommendations were implemented. The presence of the narrow berm along the upstream slope just above water level (See Photograph No. 1 Appendix II) is believed to be the top of the upstream clay berm recommended in the SCS report. This berm was not included in the original dam design.

- ① SEEPAGE AREA APPROXIMATELY 20 FT WIDE. NO FLOW OR TURBIDITY OBSERVED, BUT DOES INCLUDE IRON STAINING.

- (1) The seepage observed along the downstream slope should be monitored quarterly and after periods of high pool levels to detect any increase in flow rates which may cause piping within the embankment.

7.3.1 Seepage present along the downstream toe should be monitored quarterly to detect any increase in flow rates which may cause piping within the embankment.

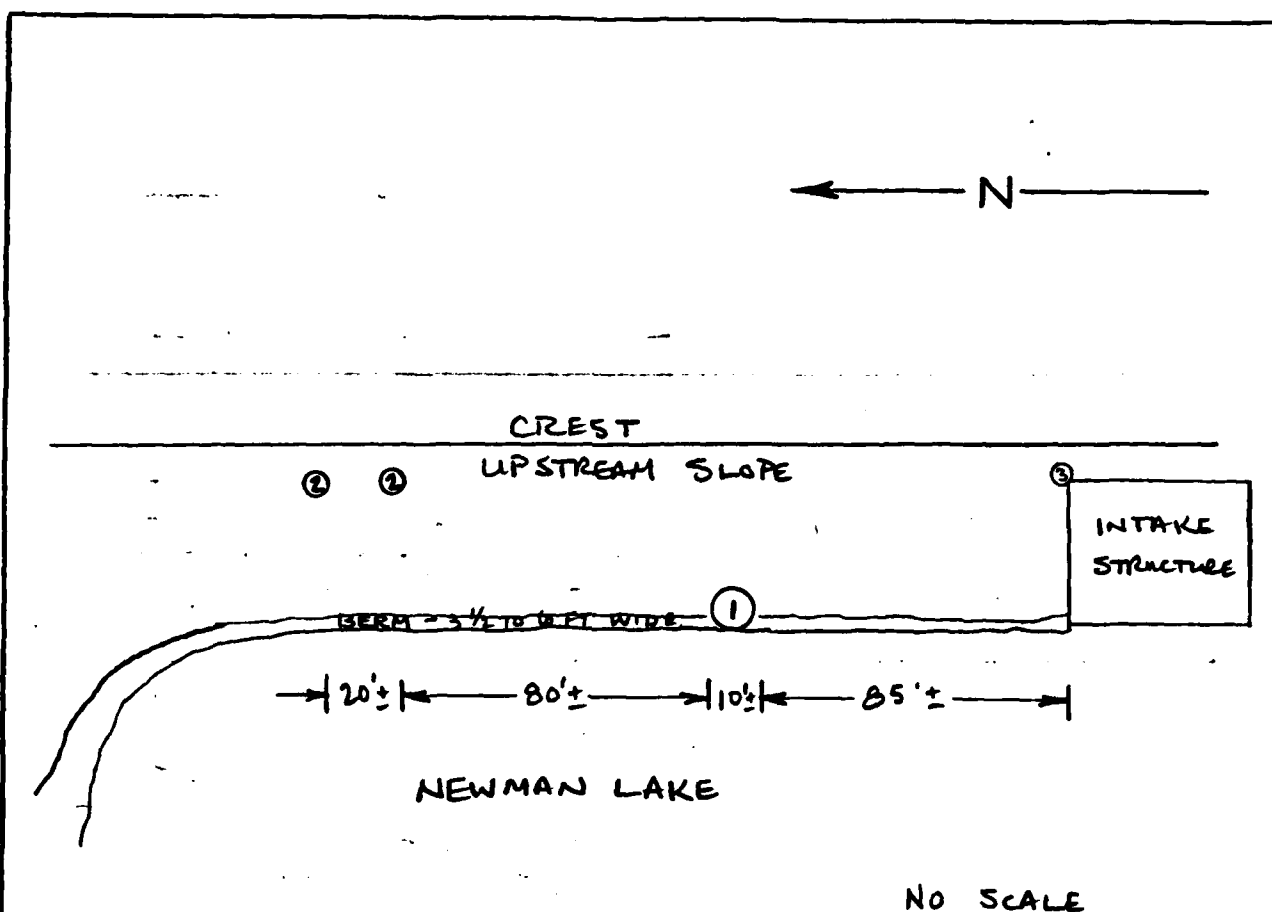
SHEET NO. 2 OF 2  
JOB NO. V90106

The shallow washes described on the upstream slope do not present any problem. The presence of a good vegetative cover at wave level on the upstream slopes appears to be controlling wave erosion, consequently corrective measures are not believed necessary. The muskrat holes do not presently create an unsafe condition, however, future burrowing could result in numerous voids in the embankment which could be potentially hazardous under certain conditions. It is recommended that the existing holes be backfilled and that any future burrows be backfilled as they appear.

- ① 10 FT ± WIDE AREA, NUMEROUS MUSKRAT (?) HOLES
- ② MINOR SURFACE EROSION; 6" DEEP, 1' WIDE, 2' LONG
- ③ MUSKRAT BURROW

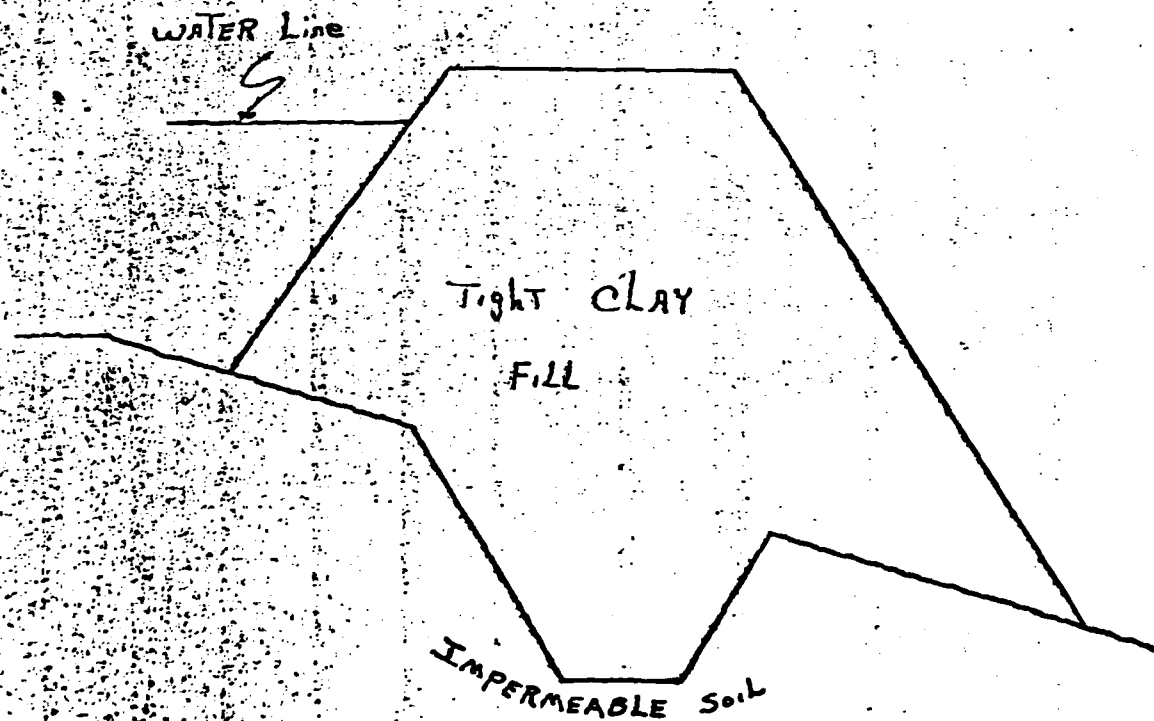
FIG. 2

3. If the permeable topsoil had been stripped off and the structure keyed into the impermeable layer as shown in Figure 2, then with the good fill material available at this site and the relatively low water levels involved, probably no appreciable seepage would have occurred.
